ANNUAL REPORT FOR 2003

Deer Creek Mitigation Site
Carteret County
Project No. 6.16901T
TIP No. R-2105 WM

Prepared By:
Office of Natural Environment & Roadside Environmental Unit
North Carolina Department of Transportation
December 2003

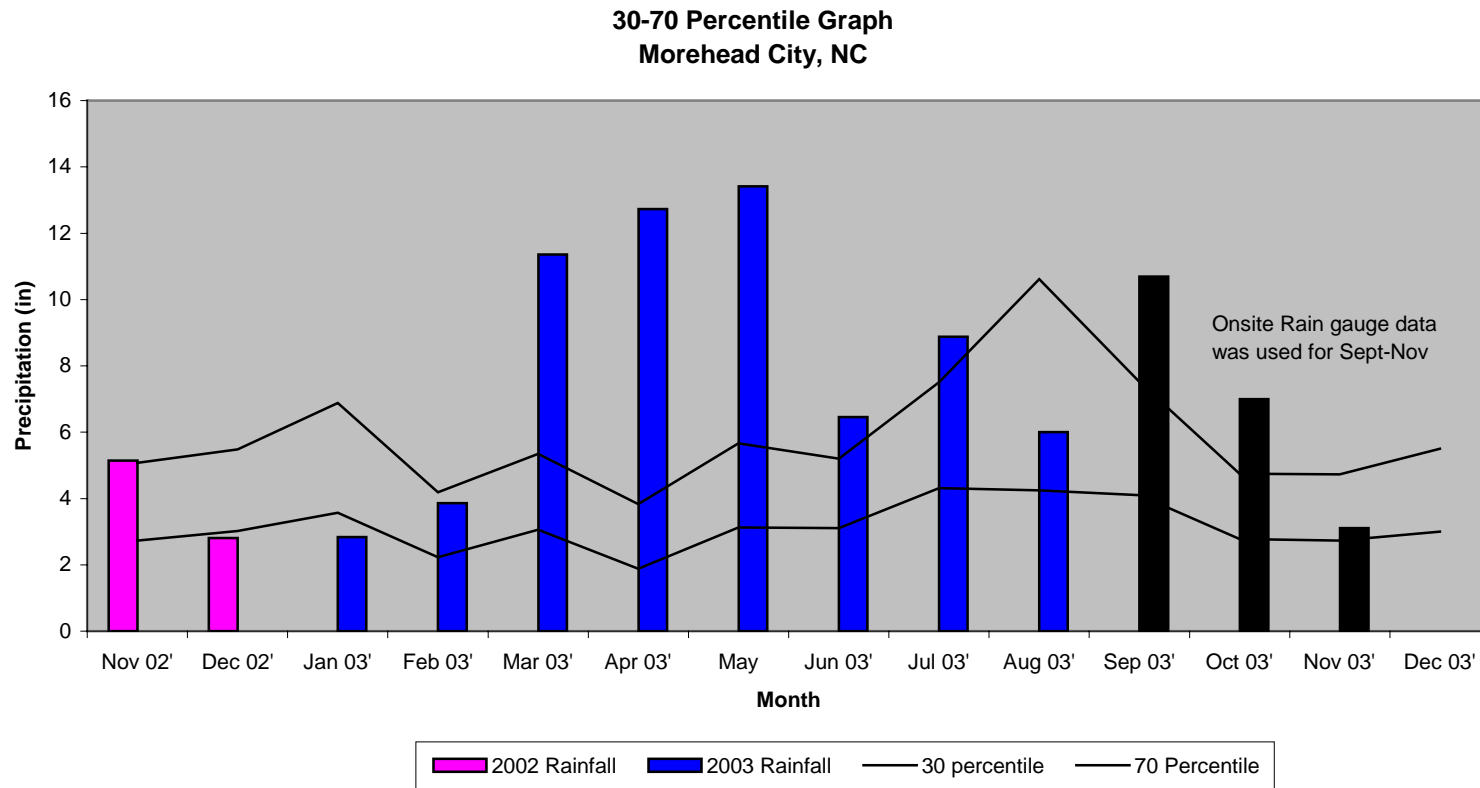
Figure 3. Deer Creek 30-70 Percentile Graph

Figure 3 is a comparison of 2002 and 2003 monthly rainfall to historical precipitation for the area. The two lines represent the 30th and 70th percentiles of monthly precipitation for Morehead City, NC. These percentiles represent monthly rainfall data collected between 1972 and 2003. The NC State Climate Office provided all historical and current monthly rainfall data for Morehead City.

For the 2003-year, March, April, May, June, July, September, and October experienced above average rainfall. The months of December (02') and January recorded below average rainfall for the site. November (02'), February, August, and November experienced average rainfall. Overall, the site met hydrologic criteria in a year of above average climate conditions; however, rainfall is not the primary hydrologic influence for the site.
